TECHNICAL REPORT HL-80-12

UTILIZATION OF FILTER FABRIC FOR STREAMBANK PROTECTION APPLICATIONS

Malcolm P. Keown, Elba A. Dardeau, Jr.

July 1980
Final Report

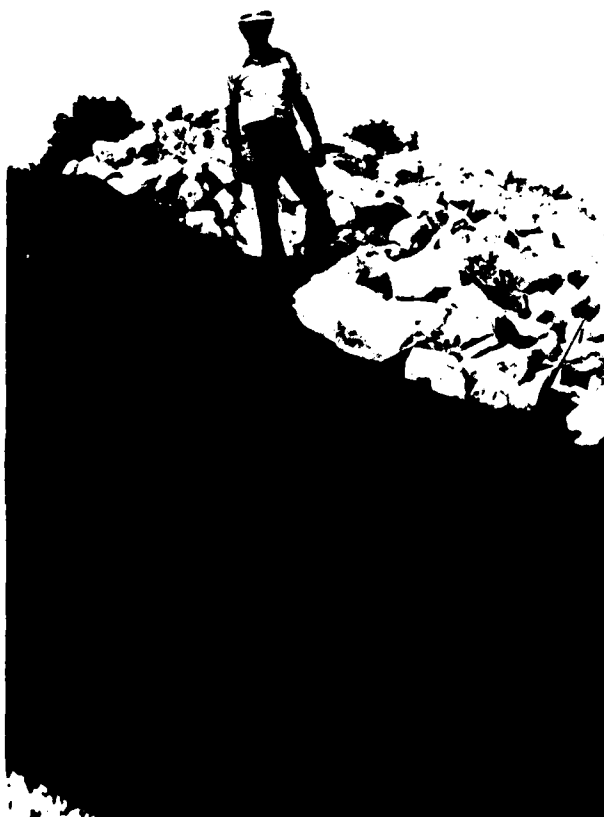
Figure 15. Loosely placed
filter fabric of the Little
Cut section of the Tennessee-
Tombigbee Waterway

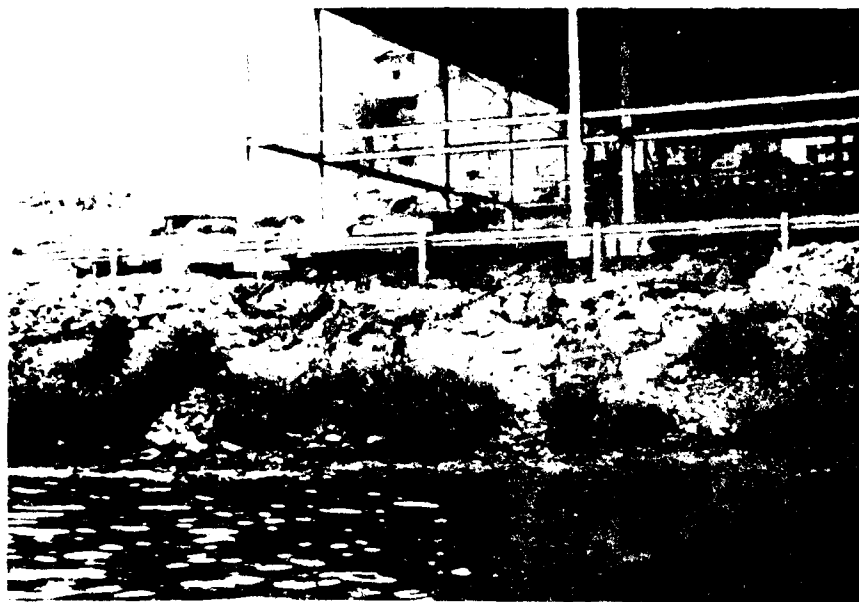
57. Partial failure of the revetment occurred in March 1972 (Figure 30). As a result of this failure, an inspection was conducted by ORP personnel on 29 March 1972 after the water had receded to 4 ft below the top of the original concrete slurry revetment. The investigation revealed that in many locations the 1971 protection had been placed on top of the original concrete slurry revetment with no toe support to prevent the stone from sliding downslope (Figure 31). The original contract drawings (Figure 29) clearly indicate that the new riprap should have been keyed through the surface of the existing protection as toe support. In a number of sections the riprap had slid into the river, thus exposing and often tearing the filter fabric.

Figure 30. Damage to bank protection at Wheeling Wharf Parking Garage after the 1972 failure. Riprap has slid down the slope into the river and the filter fabric has ripped.

58. Repair of the damaged revetment was requested on 19 June 1973 by the Engineering Division of ORP and was completed by personnel of the Operations and Maintenance Branch on 13 September 1973. Figure 32 shows a profile view of a typical section of the repairs to the slope protection. The total cost of the 1973 repairs was \$33,700 which included removal of the 1971 revetment and part of the lower bituminous pavement, purchase of filter fabric (Poly-Filter X, manufactured by Carthage Mills of Cincinnati, Ohio) and limestone riprap, entrenchment of toe stone through the original concrete slurry revetment, placement of the riprap, repaving some of the eroded bituminous pavement, and replacement of some of the bituminous pavement on the lowermost parking level with a slurry-grouted riprap. Where possible the existing filter fabric (Filter-X) was left in place; but where the fabric was damaged or missing, new fabric (Poly-Filter X) was used. The U. S. Army Engineer Division, Ohio River (ORD) selected this revetment as an existing site for monitoring as a

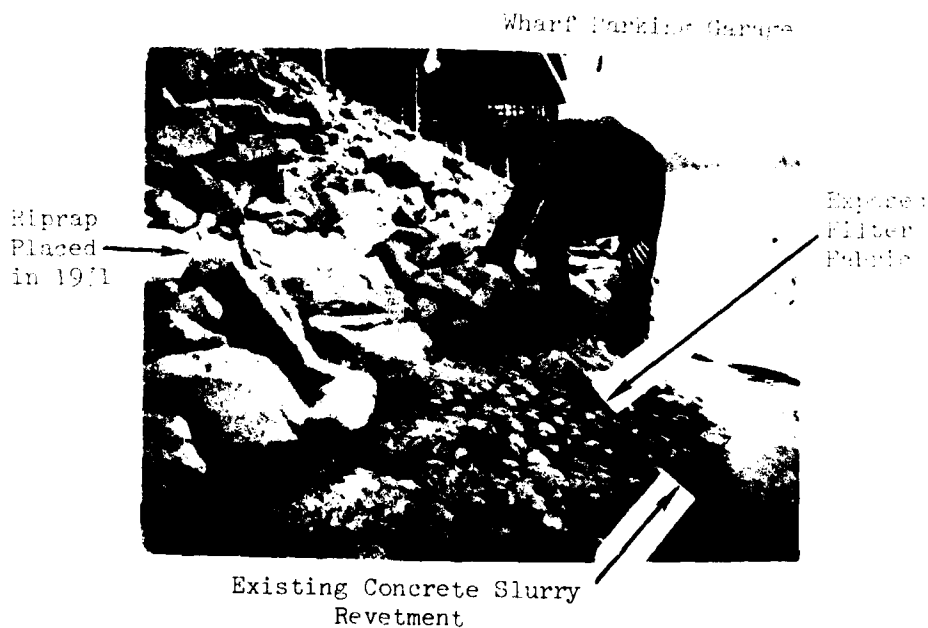
Figure 31. Condition of revetment of Wheeling Wharf Parking Garage on 31 March 1972 showing how riprap and filter fabric were placed directly over existing concrete slurry revetment without entrenching toe.

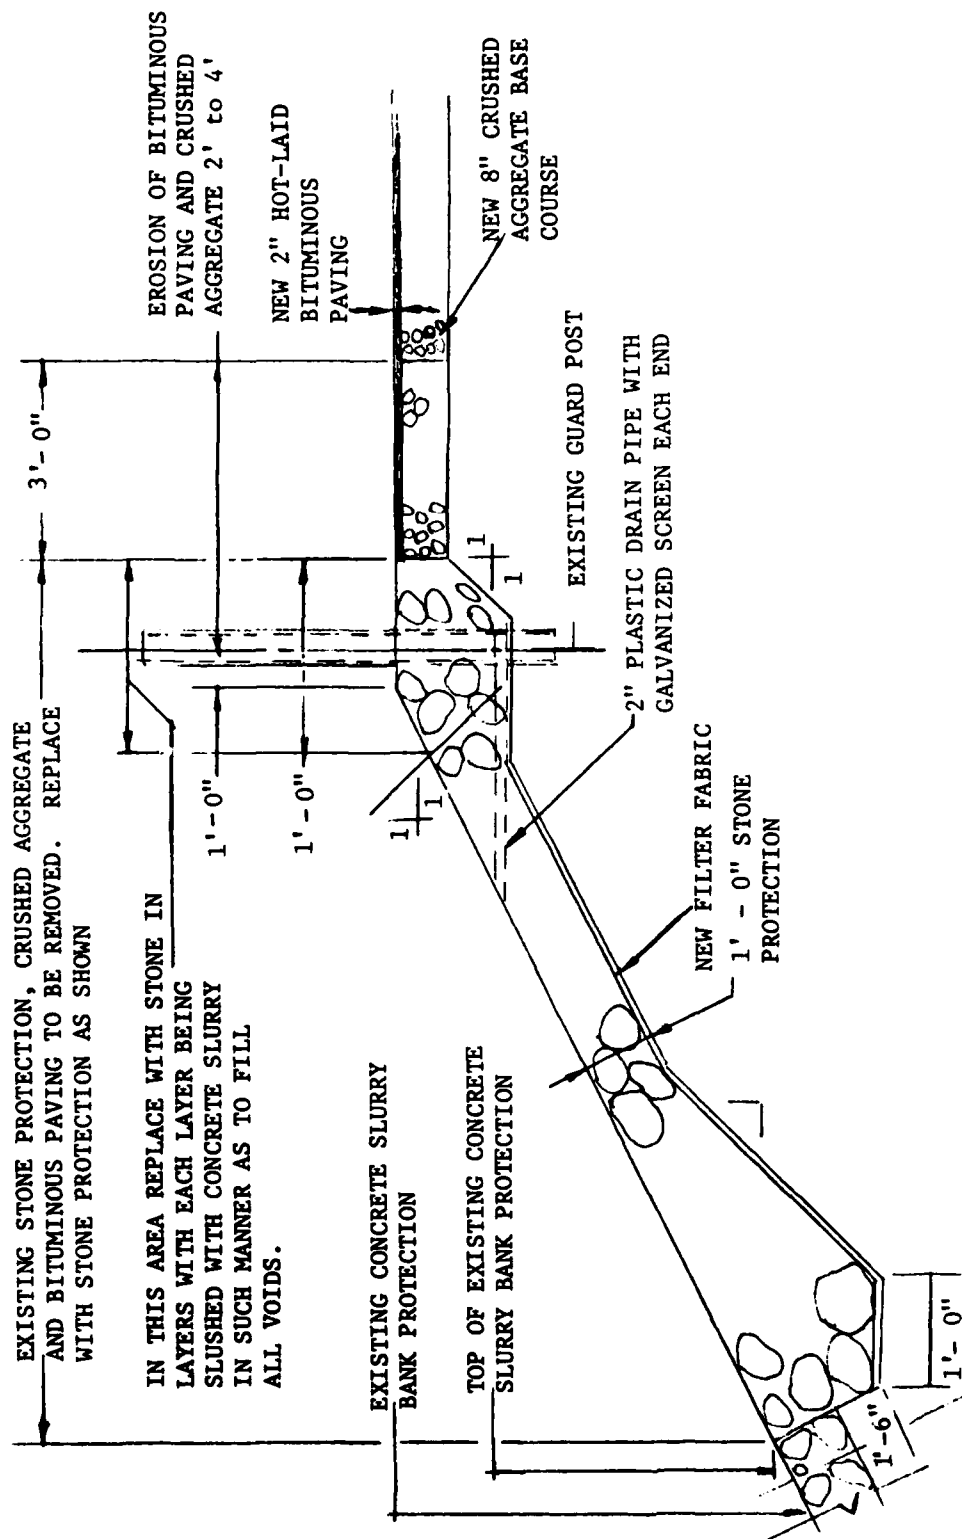
Figure 32. Profile view of 1973 repair to revetment, Wheeling Wharf Parking Garage (adapted from Ohio River Hannibal Locks and Dam, Ohio and West Virginia, Wharf Parking Garage, Slope Repair Drawing No. O-LHA-100167.1, ORP, not dated)

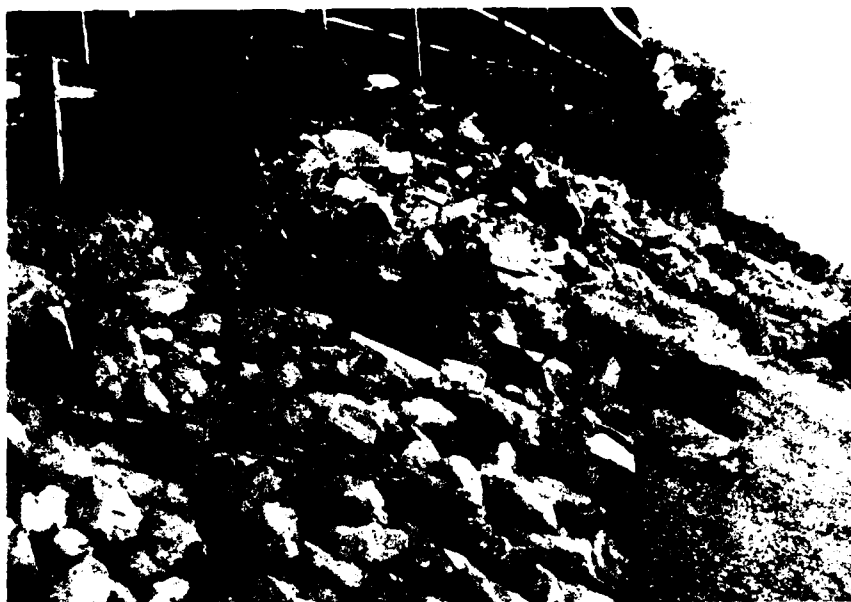
59. In general, the fabric and stone have performed well since the 1973 repairs. The WES Section 32 Program evaluation team accompanied by ORP and ORD personnel inspected the site on 22 June 1978 and found that some of the fabric placed in 1973 had been exposed due to removal of rock but that no tears in the fabric were visible (Figure 33). The WES team also found that the bituminous pavement adjacent to the guard rail had failed in a few places (Figure 34) and that some of the 1973 stone protection had slid over the original concrete slurry and into the river (Figure 35). ORP personnel inspected the condition of the revetment on 29 Mar 1979 after subsidence of the March 1979 high water. They found there was further damage to the revetment as evidenced by Figure 36. At the time of this inspection, the fabric had been pulled away from the bank and more riprap had slid into the river.

Figure 33. Exposed but undamaged filter fabric detected by
 WSP Section 2. Inspection evaluation team at the Wheeling
 Wharf Parking Garage site (22 June 1978)

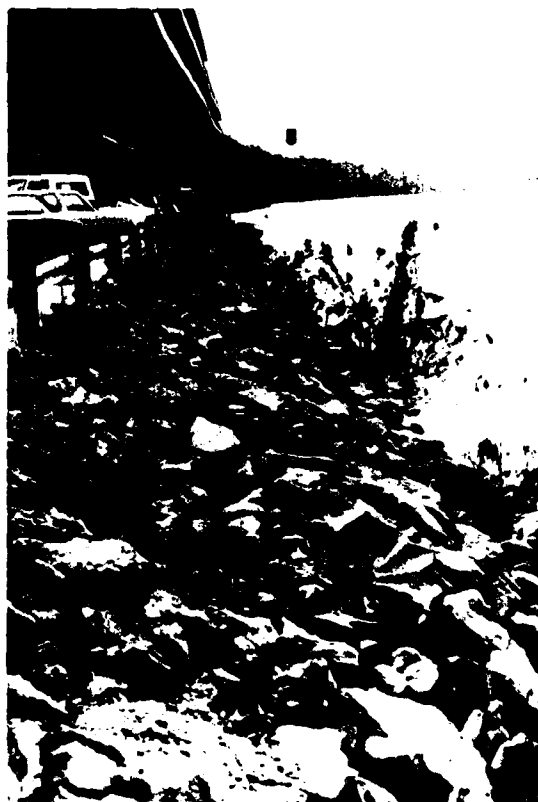
Figure 55. Condition of revetment at Wheeling Wharf Parking Garage on 19 Mar 1979. High flows during March 1979 pulled the filter fabric away from the bank and caused more riprap to slide into the river

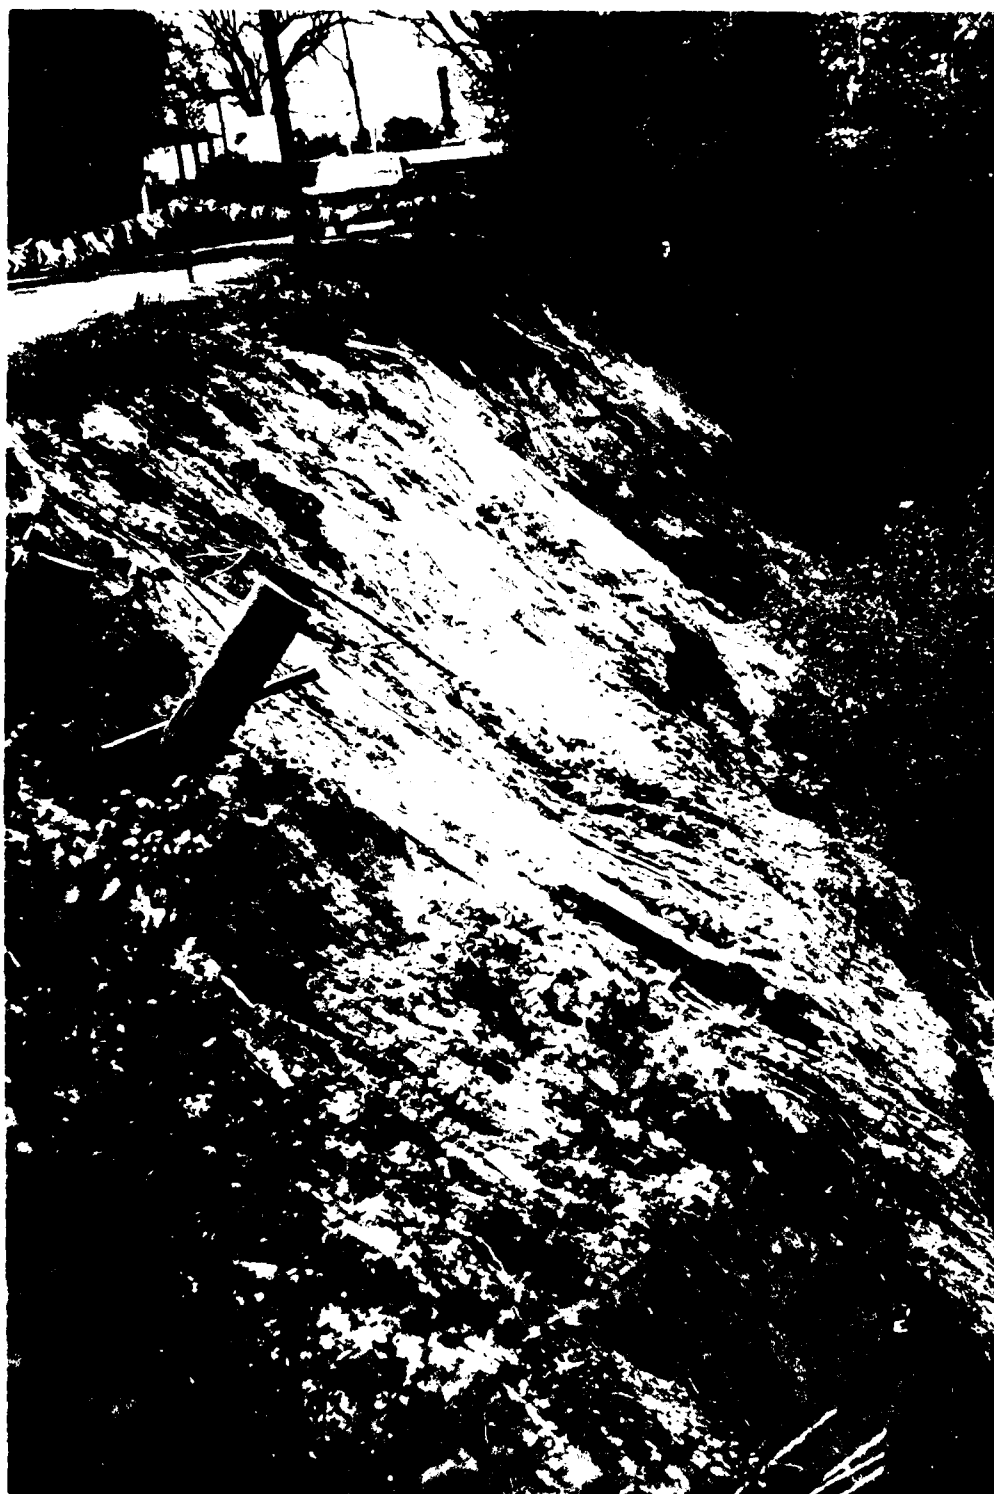
Figure 46. Upstream view of erosion on Little Rockfish Creek, Hope Mills, N. C., as it appeared in April 1973

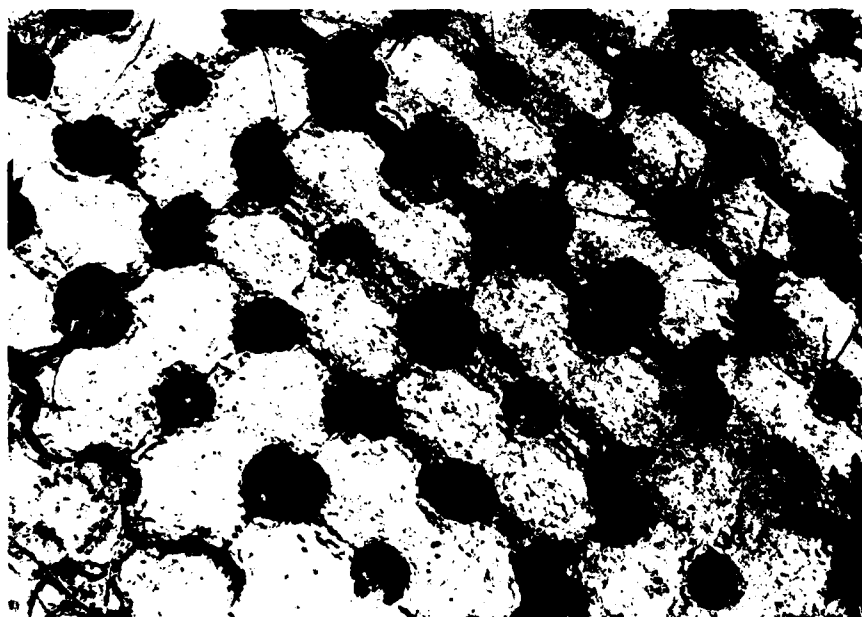
Figure 59. Filter fabric visible through precast cellular blocks Morameal Revetment, La. (9 May 1978)

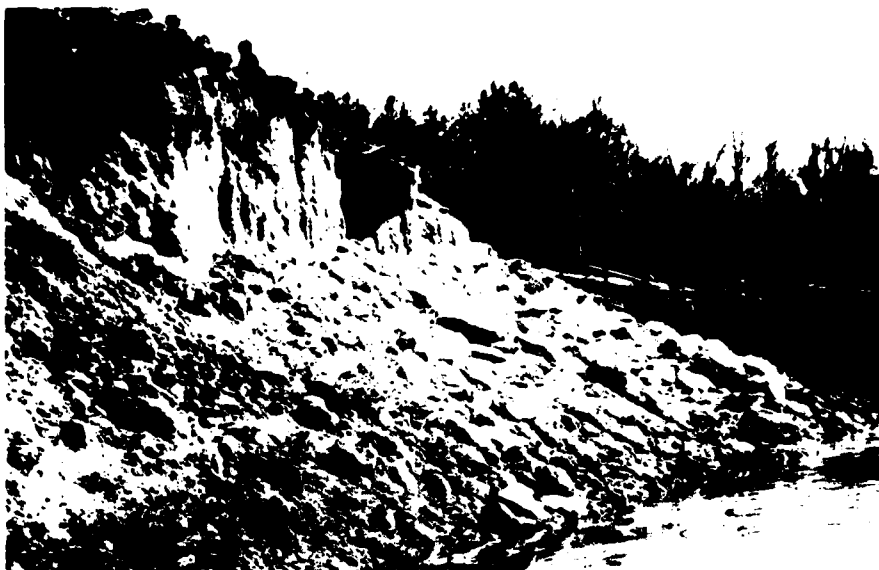
Figure 64. Jetty system on Tangipahoa River near Independence, La., after failure caused by flooding (1977) (photograph courtesy of ERCO Systems, Inc.)
